Geomorphology and Flood-Plain Vegetation of the Sprague and Lower Sycan Rivers, Klamath Basin, Oregon

Scientific Investigations Report 2014–5223

By Jim E. O'Connor, Patricia F. McDowell, Pollyanna Lind,
Christine G. Rasmussen, and Mackenzie K. Keith

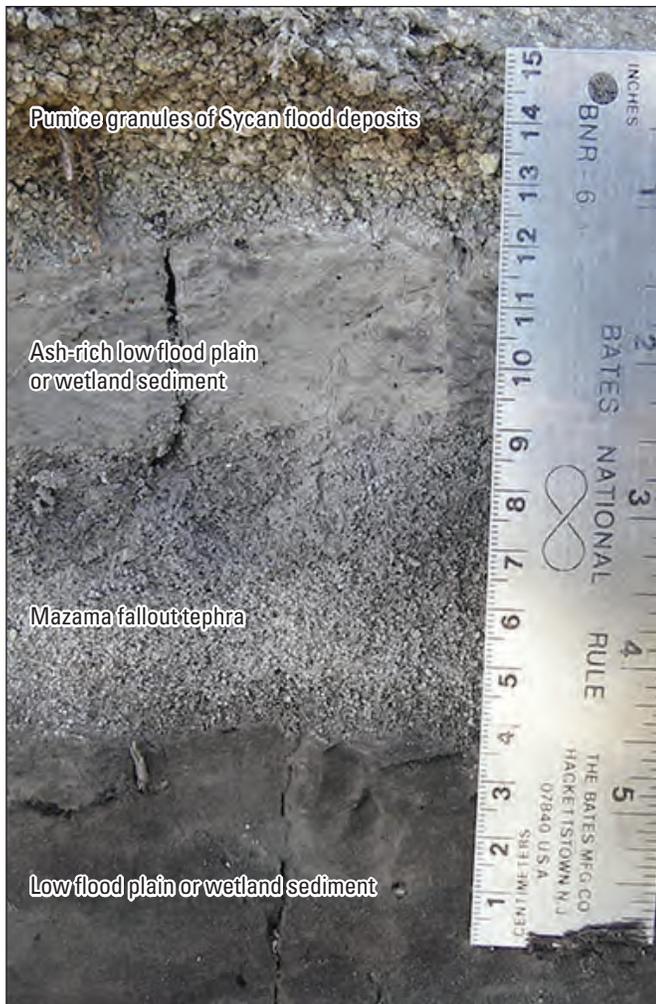
Figure 10. Mazama fallout tephra and Sycan flood deposits exposed at site 7/24/07-2/3, Sycan River flood-plain kilometer (SYFK) 0.02, Sprague River study area, Oregon. Photograph taken by J.E. O'Connor, U.S. Geological Survey, September 12, 2007.

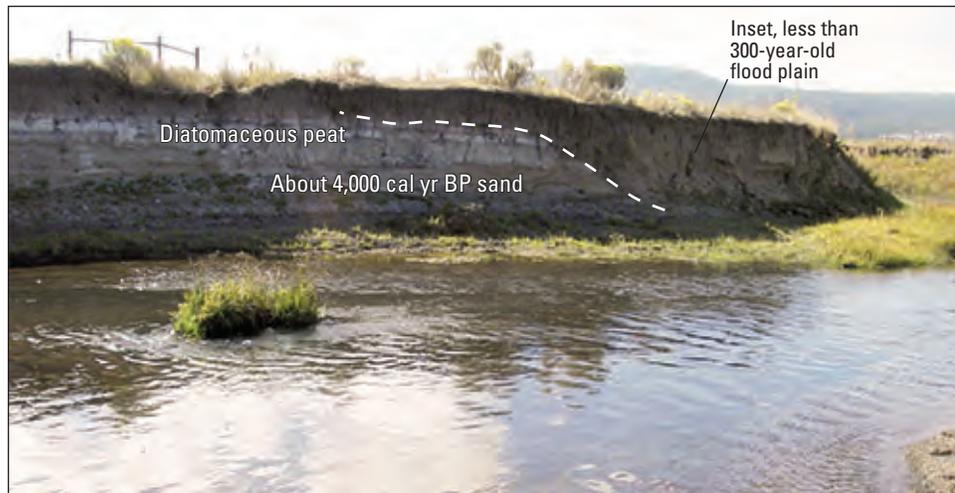
Figure 11. Late Holocene inset flood-plain deposits at the (A) right-bank exposure at North Fork Sprague River flood-plain kilometer (NFFK) 0.7, and (B) left-bank exposure at NFFK 0.9, along North Fork Sprague River, Oregon. Photograph taken by J.E. O'Connor, U.S. Geological Survey, September 14, 2007.

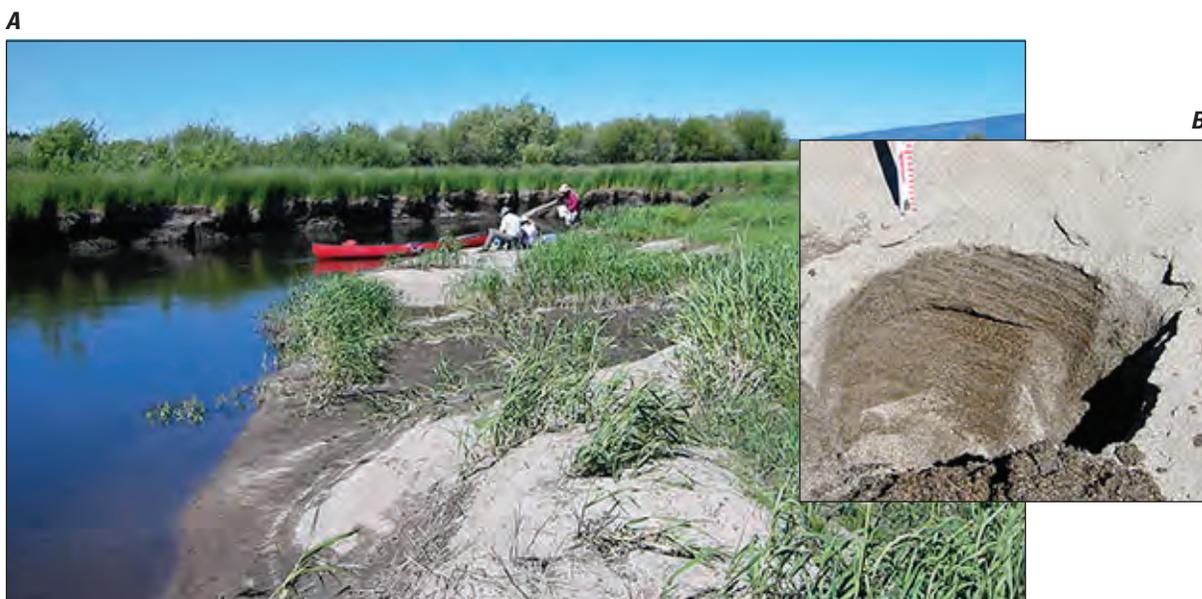
Figure 15. Point bar deposits at survey site 6/23/06-5 with (A) view downstream of partly vegetated point bar mantled with coarse sand deposited during 2006 high flows, and (B) 30-centimeter-deep excavation into 2006 high flow deposits showing bedded coarse sand composed mainly of pumice grains, Upper Valley segment, Sprague River study area, Oregon. Photographs taken by J.E. O'Connor, U.S. Geological Survey, June 23, 2006. Descriptions of survey sites are provided in [appendix G](#).

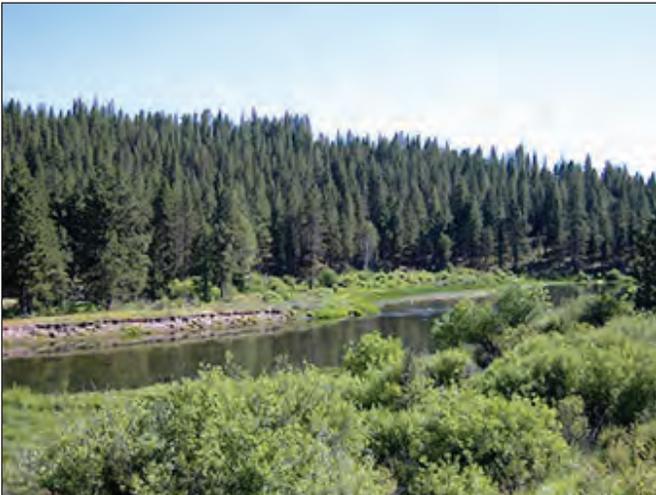
Figure 21. Braymill valley segment looking southwest from near flood-plain kilometer 14.5, Sprague River Basin, Oregon. Photograph taken by J.E. O’Connor, U.S. Geological Survey, July 14, 2005.

The Braymill valley segment also is a narrow canyon segment ([fig. 21](#)), but is distinguished from the Chiloquin Canyon valley segment by its much flatter gradient—0.00024 compared to the eight-times-steeper slope of the Chiloquin Canyon valley segment ([fig. 17](#), [table 2](#)). The Braymill valley segment extends 5.8 km from the valley contraction at FK 17.2 to the slope inflection at the head of the Chiloquin Canyon segment at FK 11.4. Within this reach, the flood plain averages 110 m in width and is flanked by bedrock, colluvial slopes, narrow flood-plain surfaces, and terraces rising 10 m higher than the channel ([fig. 16](#)). As with the Chiloquin Canyon valley segment, sinuosity is low (1.07) and the low-flow channel occupies about one-third of the total flood-plain width. Vegetation within the geomorphic flood plain also is similar to that of the Chiloquin Canyon segment: predominantly herbaceous grasses and forbs, shrubs, and ponderosa pine.

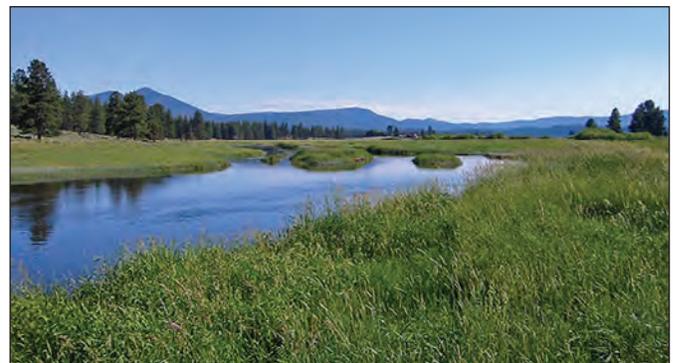
Figure 22. Kamkaun Spring valley segment at flood-plain kilometer 26.8, Sprague River Basin, Oregon. Photograph taken by J.E. O’Connor, U.S. Geological Survey, June 25, 2006.

The Kamkaun Spring valley segment ([fig. 22](#)) extends 15.2 km from FK 32.4 at the downstream end of the S’Ocholis Canyon valley segment to the head of the Braymill valley segment at FK 17.2. This is a sinuous (1.59), low-gradient (slope 0.00015) reach with broad flood plains ([fig. 17](#), [table 2](#)). The channel typically is some distance from valley margins ([fig. 16](#)). This segment locally is referred to as the “Nine Mile reach.” The flood-plain and flanking main-stem valley fill are bounded by bedrock uplands and terraces as much as 7 m higher than the geomorphic flood plain. The average width of the geomorphic flood plain is 500 m ([fig. 17](#)), but this area of active channel migration for the last several thousand years is flanked by broad valleys and basins (chiefly mapped as main-stem valley fill; plate 1) that also are inundated during the largest floods. The Sprague River meanders through the flood plain (which in turn is sinuous) and has left several oxbow ponds and abandoned channels. The average channel width is about 33.8 m ([table 2](#); [fig. 18](#)), and the channel mostly flows on sand and gravel, but also in places flows on indurated clay and silt locally scoured into several-meter-deep holes and chutes. Former fords and irrigation diversions are marked by placed rock and coarse gravel accumulations spanning the channel. Flood-plain vegetation is composed chiefly of herbaceous grasses and forbs, with abundant shrubs and local tree-form willows (*Salix* sp.).

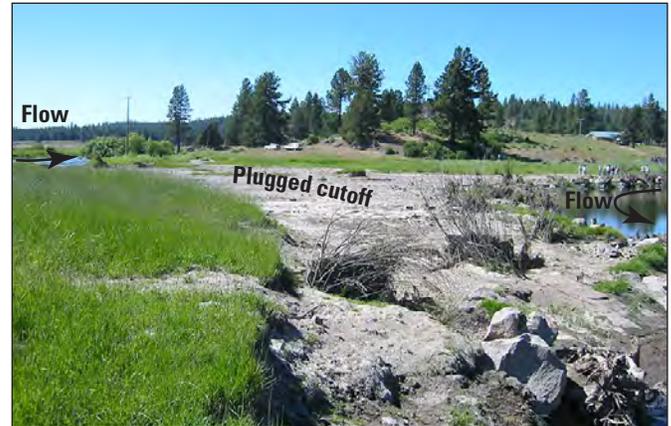
Figure 23. Filled cutoff channel at flood-plain kilometer 25.3, Kamkaun Spring valley segment, Sprague River Basin, Oregon. The upstream outside bend of rechanneled meander bend (right part of photograph) is protected with rock-anchored wood. Photograph taken by J.E. O'Connor, U.S. Geological Survey, June 22, 2006.

These spring complexes provide a reliable water source and inhibit the Sprague River from freezing over, which, along with the wide flood plains, have led to a long history of settlement in this reach. Archeological sites on terraces and hillslopes flanking the flood plain in this reach possibly date back to more than 8,000 years ago (Spier, 1930; Cressman and others, 1956; Butler and others, 2010). Early homesteaders began cattle ranching here at about the time Frank McCready settled in 1915 on the peninsula of the terrace jutting into the flood plain between FKs 31.9 and 28.7 (Greg Harris, Frank McCready's grandson and present landowner, oral commun., September 13, 2007). To enable cattle ranching and flood-plain irrigation, diversion dams and ditches were emplaced within this reach by the mid-1920s (USGS Oregon Water Science Center, Portland, Oregon, measurement station records for station 11501000). Construction of the OC&E railroad to Bly and concurrent logging also proceeded through this reach in the 1920s, with the railroad grade effectively diking parts of the flood plain. More systematic levee construction and willow eradication began during 1953–54, when the U.S. Army Corps of Engineers constructed levees and dikes by excavating directly from the channel (Greg Harris, oral commun., 2007). More recent channel and flood-plain modifications in this segment include filling of meander cutoffs and associated bank stabilization, and local levee breaching (fig. 23).

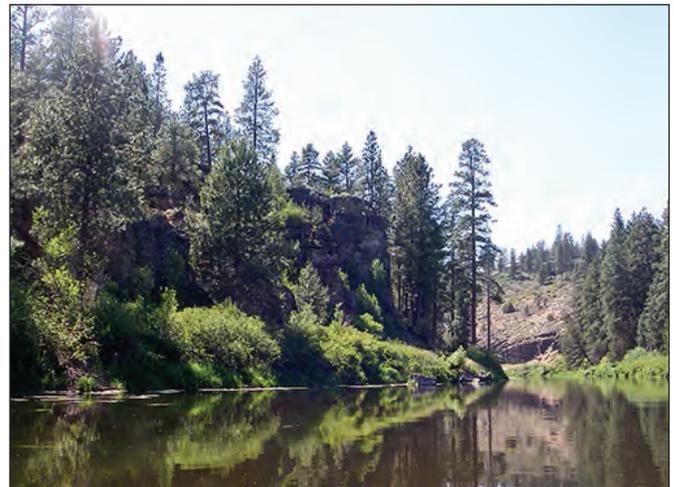
Figure 24. S'Ocholis Canyon valley segment at flood-plain kilometer 34.1, Sprague River Basin, Oregon. Photograph taken by J.E. O'Connor, U.S. Geological Survey, July 15, 2006.

The S'Ocholis Canyon valley segment (fig. 24) encompasses 15.8 km of confined canyon and narrow valley between the much wider Buttes of the Gods and Kamkaun Spring valley segments. Its upstream boundary (FK 48.2) is close to the confluence of Trout Creek and the Sprague River at FK 48.0. The geomorphic flood plain averages 170 m wide and is everywhere less than 500 m wide (table 2; fig. 17). The flood plain is flanked mostly by steep bedrock and colluvium-mantled hillslopes, low terraces of as much as 5 m higher than the active flood plain, and tributary flood plains and fans (fig. 16). The flood plain is slightly wider between FKs 39.4 and 43.2, where it is confined by low terraces and where a large area of main-stem valley fill is contiguous to the geomorphic flood plain between FKs 42.3 and 42.6.

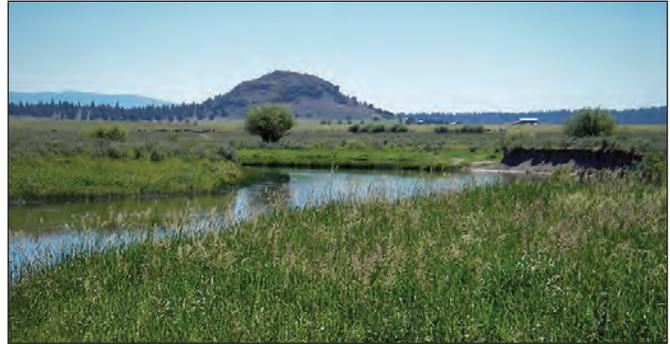
Figure 25. Buttes of the Gods valley segment looking upstream from flood-plain kilometer 49.2, Sprague River Basin, Oregon. Photograph taken by J.E. O'Connor, U.S. Geological Survey, June 28, 2005.

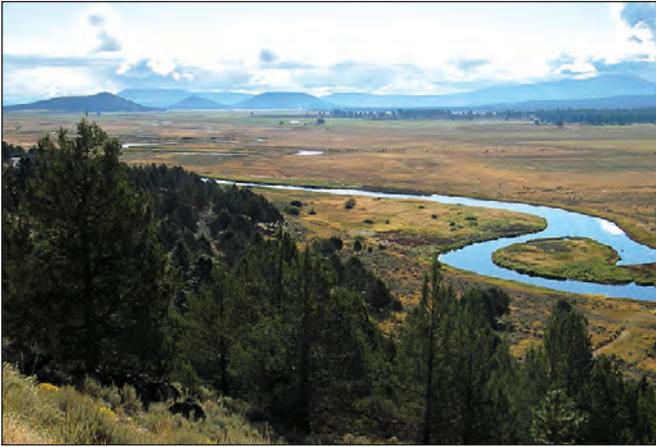
Figure 26. Council Butte valley segment looking upstream from near flood-plain kilometer 59.2, Sprague River Basin, Oregon. Photograph taken by J.E. O'Connor, U.S. Geological Survey, September 16, 2006.

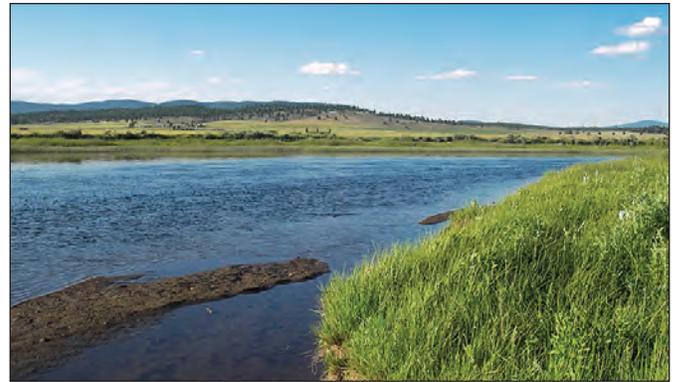
Figure 27. Beatty-Sycan valley segment looking northwest (upstream) from flood-plain kilometer 78.5, Sprague River Basin, Oregon. Photograph taken by J.E. O'Connor, U.S. Geological Survey, June 26, 2006.

The Beatty-Sycan valley segment (fig. 27) is a short reach extending 4.2 km from the downstream end of Beatty Gap at FK 81.0 to the Sycan River confluence with the Sprague River at FK 76.8. Like the two downstream segments, this is a wide and unconfined reach containing a sinuous (1.68) Sprague River. This segment constitutes the upper part of the Sprague River Valley. The geomorphic flood plain averages 910 m wide (table 2, fig. 17) and is mostly bounded by main-stem valley fill that probably is inundated during large

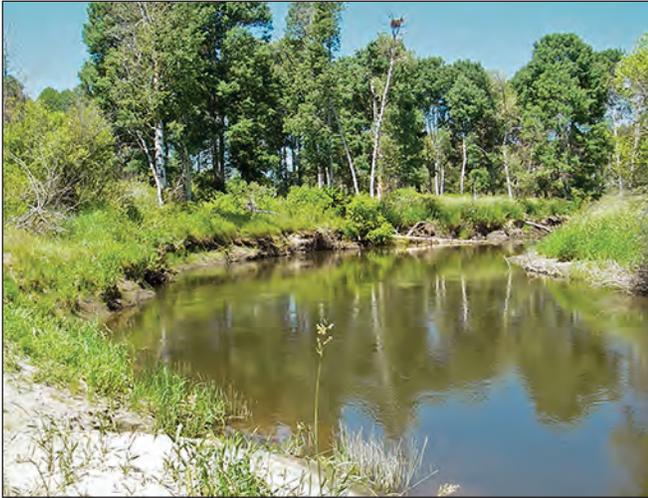
Figure 28. Beatty Gap valley segment looking west (downstream) from flood-plain kilometer 85.2, Sprague River Basin, Oregon. Photograph taken by J.E. O'Connor, U.S. Geological Survey, June 26, 2006.

The flood plain has abundant shrub and tree cover, including willow, aspen, currant (*Ribes* L.), and rose (*Rosa* L.; fig. 28). Slightly higher and more xeric flood-plain surfaces are vegetated with sagebrush, rabbitbrush (*Chrysothamnus* Nutt.), and grasses. The channel margin and flanking point bars are vegetated with grasses, sedges, rushes, and common reed canarygrass. Wood accumulations, including some large ponderosa pine boles originating on adjacent hillslopes, locally flank and span the channel.

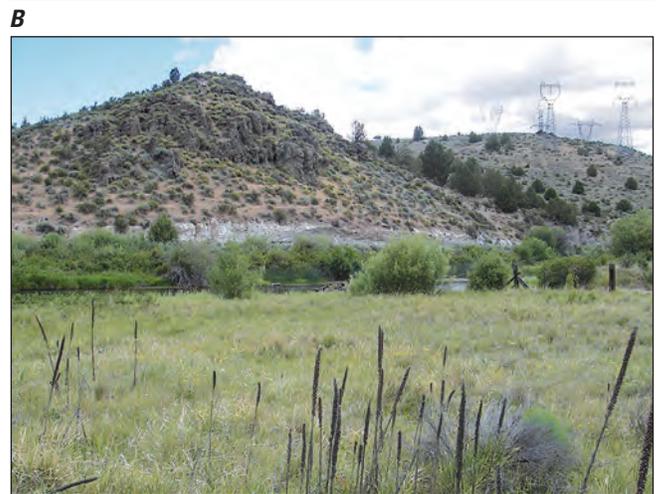
Figure 29. Approximately matched locations at flood-plain kilometer 81.4 near the downstream end of the Beatty Gap valley segment, Sprague River Basin, Oregon. (A) Former Beatty Bridge, photograph probably taken May 21, 1904, during establishment of streamflow-gaging station near present site of Oregon Water Resources Department station 11497500. (B) Photograph taken close to the same location on June 29, 2007, showing increase of riparian willow (*Salix* sp.), hillslope juniper (*Juniperus occidentalis*), and transmission towers. Source of figure 29A: Bureau of Reclamation, Klamath Waters Digital Library; <http://digitallib.oit.edu/cdm/singleitem/collection/kwl/id/522/rec/5>, accessed February 11, 2012). Figure 29B taken by J.E. O'Connor, U.S. Geological Survey.

The Beatty Gap valley segment has few diversions, ditches, and levees. It is crossed by a private bridge at FK 89.3 and a concrete bridge along the OC&E railroad grade at FK 87.7. Historically, a wagon road and later a highway crossing spanned the river at FK 81.5 (fig. 29). State Highway 140 traverses the southern edge of the flood plain, and the

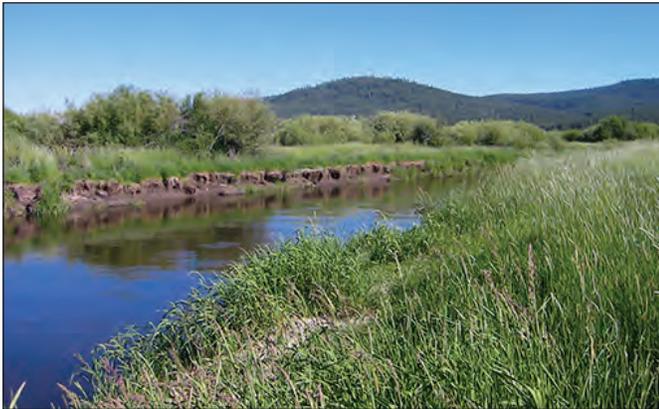
Figure 30. Upper Valley segment looking downstream from flood-plain kilometer 88.5, Sprague River Basin, Oregon. Photograph taken by J.E. O'Connor, U.S. Geological Survey, June 23, 2006.

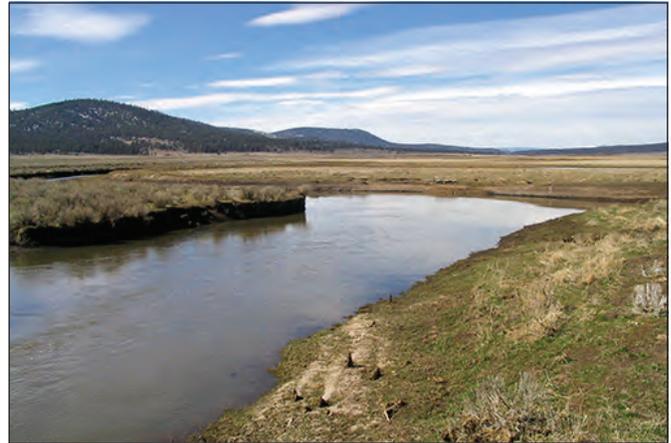
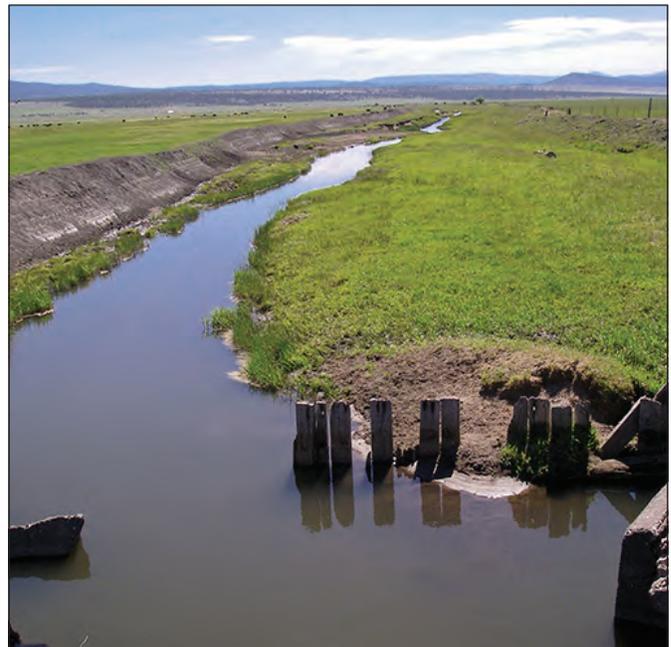
Figure 31. South Fork valley segment looking (A) downstream from Ivory Pine Road bridge crossing at flood-plain kilometer (FK) 94.3 (March 9, 2004); and (B) upstream from diversion at FK 98.6 (June 20, 2007), Sprague River Basin, Oregon. Photographs taken by J.E. O'Connor, U.S. Geological Survey.

The South Fork valley segment (fig. 31) spans 13.1 km from FK 106.3, 5.7 km east-southeast of Bly, to FK 93.2, at the confluence of the South Fork Sprague River with the North Fork Sprague River. This segment encompasses the broad alluvial valley from where the river leaves the uplands dividing the Sprague River Basin from those basins to the east. The geomorphic flood plain is flanked by active and

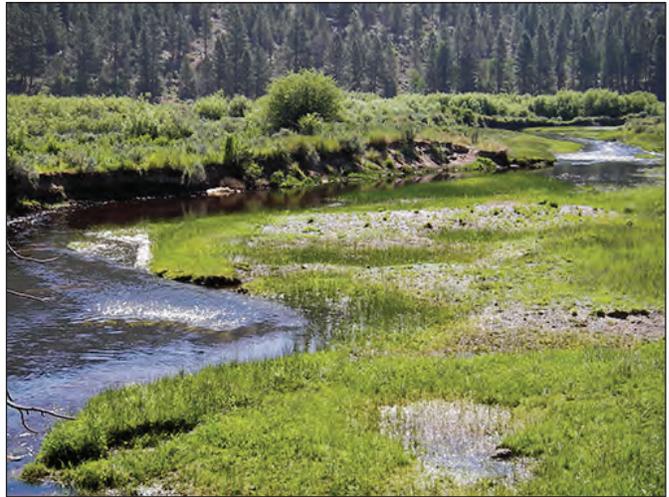
Figure 33. Lower Sycan valley segment looking downstream from Sycan River flood-plain kilometer 10.7, Sprague River Basin, Oregon. Photograph taken by J.E. O'Connor, U.S. Geological Survey, June 30, 2005.

The Lower Sycan valley segment (fig. 33) encompasses the Sycan River valley bottom from near where it leaves Sycan Canyon to the Sycan River confluence with the Sprague River. This valley segment is 10.6 km long (table 2), not including the 0.75-km-long traverse across the Sprague River flood plain at the confluence of the Sycan and Sprague Rivers. Flood-plain width generally increases downstream, from less than 200 m near the downstream end of Sycan Canyon, to more than 1,000 m as the Sycan River flood plain joins the Sprague River flood plain. The Sycan River flood plain is adjacent to Sycan flood deposits for much of its length, but is locally also flanked by bedrock, active and abandoned

The Sycan River channel averages 16.9 m wide, has a sinuosity of 1.38, and is flanked by abundant bars, mainly composed of sand (table 2; figs. 17, 18, 33). Channel substrate ranges from mostly gravel at the upstream end of the reach to sand and gravel patches partly covering indurated silt and clay, probably Tertiary lacustrine sediment, at the lower end of the reach (fig. 34).

Channel margins and low flood-plain surfaces are locally vegetated with sedges and rushes, with abundant shrub cover (including willow, rose, and currant) along former channel paths (fig. 33) and taller stream banks. Higher flood-plain surfaces mainly are vegetated with sagebrush, rabbitbrush, and upland grasses.

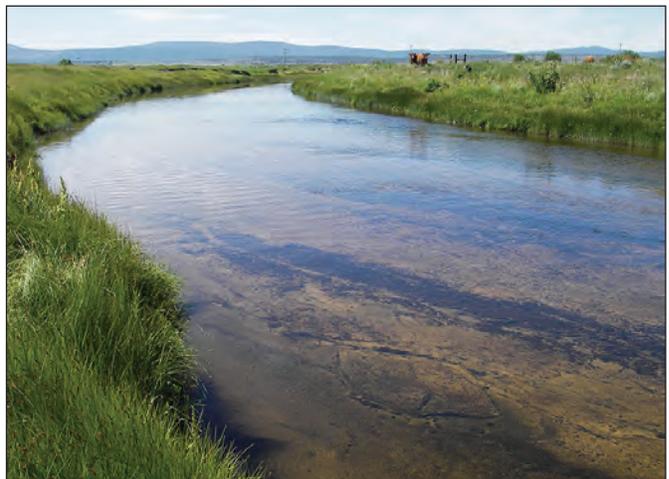
Figure 34. Sycan River flowing on Tertiary lacustrine sediment at Sycan River flood-plain kilometer 1.2 in the Lower Sycan valley segment, Sprague River Basin, Oregon. Photograph taken by J.E. O'Connor, U.S. Geological Survey, June 22, 2007.

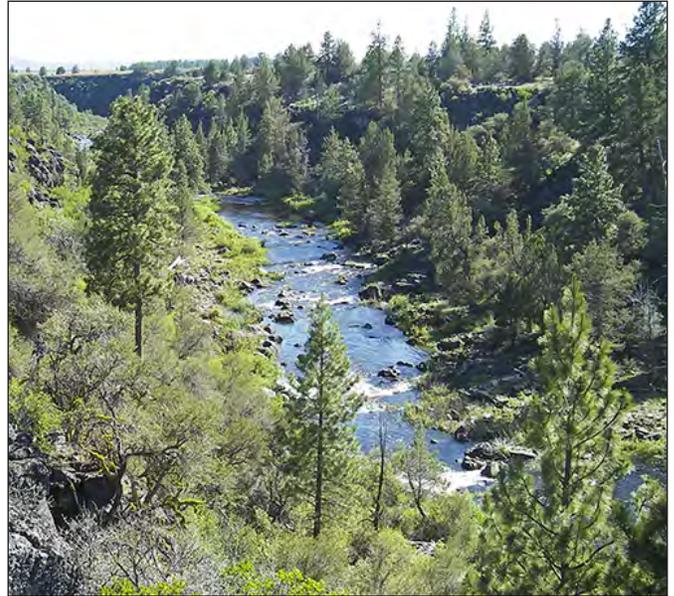
Figure 35. Coyote Bucket valley segment of the Sycan River looking downstream from near Sycan River flood-plain kilometer 13.2, Sprague River Basin, Oregon. Photograph taken by J.E. O'Connor, U.S. Geological Survey, June 24, 2006.

The Coyote Bucket valley segment (fig. 35) includes 13.4 km of the Sycan River corridor through the lower and steepest part of the Sycan Canyon, from the downstream end of Teddy Powers Meadows at SYFK 24.0 to the downstream end of the canyon at SYFK 10.6. Because aerial photography and lidar coverage is limited to downstream of SYFK 15.4, mapping and analysis is complete only for the lower part of this valley segment. For the entire segment length, mean flood-plain width is 60 m (table 2); the narrowest of any segment in the study area, and is almost everywhere confined by bedrock or colluvium. The lower part of the segment, from near the confluence of Blue Creek at SYFK 13.4 to the downstream end of the canyon at SYFK 10.6, is narrowest and steepest, corresponding to where the river cuts through the Basalt of Knot Tableland. Two small rockfall landslides encroach upon the channel in this reach.

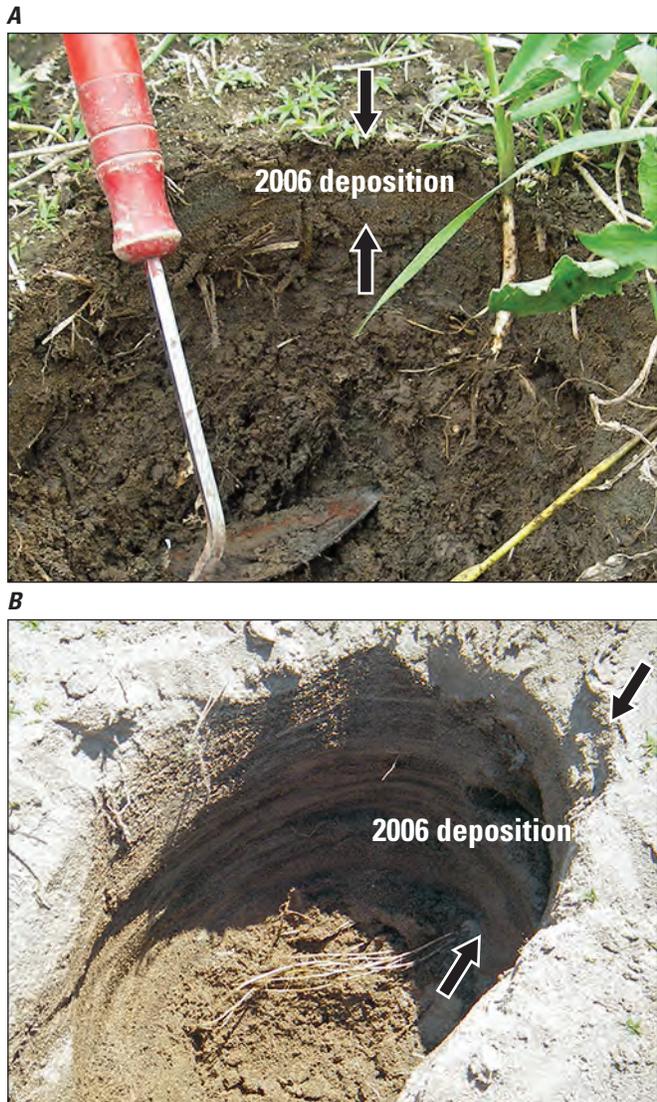
Figure 53. Examples of sediment deposition resulting from the 2006 high flows, including (A) overbank deposition of 4.5 centimeters of silt and sand on low flood-plain surface, Council Butte valley segment (survey site 6/28/06-8); and (B) deposition of 33 centimeters of sand on point bar, Beatty Gap valley segment (survey site 6/26/06-1), main-stem Sprague River, Oregon. Photographs taken by J.E. O'Connor, U.S. Geological Survey; (A) June 28, 2006; (B) June 26, 2006.

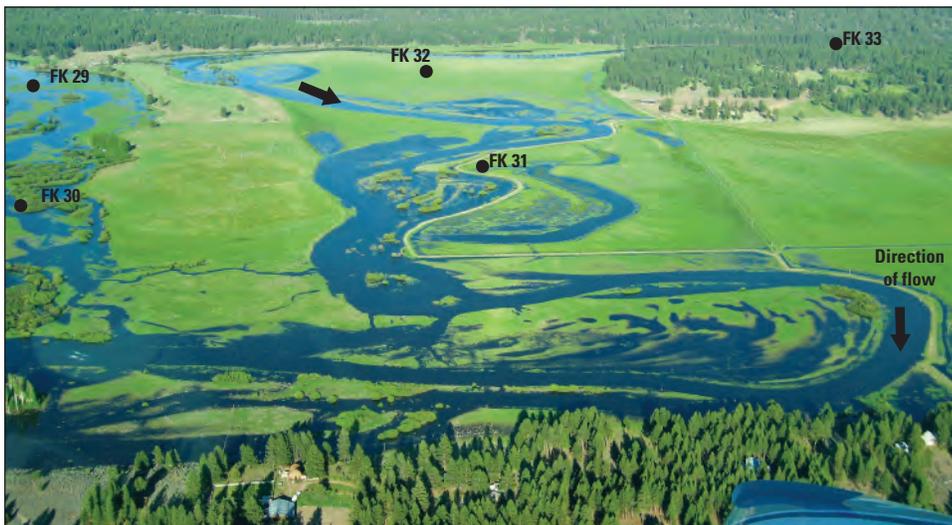
Figure 54. Kamkaun Spring valley segment, looking north, main-stem Sprague River, Oregon, during high flow in water year 2006. Photograph courtesy of Greg Koonce, Inter-Fluve Inc., May 16, 2006 (used with permission).

Bar morphology also can indicate patterns of meander growth. In particular, the orientation of scroll bars—concentric ridges developed on a point bar surface through time as it evolves (Lobeck, 1939; Hickin 1974)—support interpretations of the direction and type of channel movement. Hooke (1997) identified five major types of bar movement: (1) downstream translation, (2) upstream translation, (3) expansion (growing toward the flood-plain margin), (4) rotation, and (5) development of a compound or double-headed meander. Scroll bars are more evident in the wide valley segments. The dominant types of meander movement indicated by scroll bars in the Kamkaun Spring, Buttes of the Gods, Council Butte, and Sycan-Beatty valley segments are downstream translation (fig. 12) and expansion (fig. 54), although some bars show evidence of upstream translation and development of compound meanders.

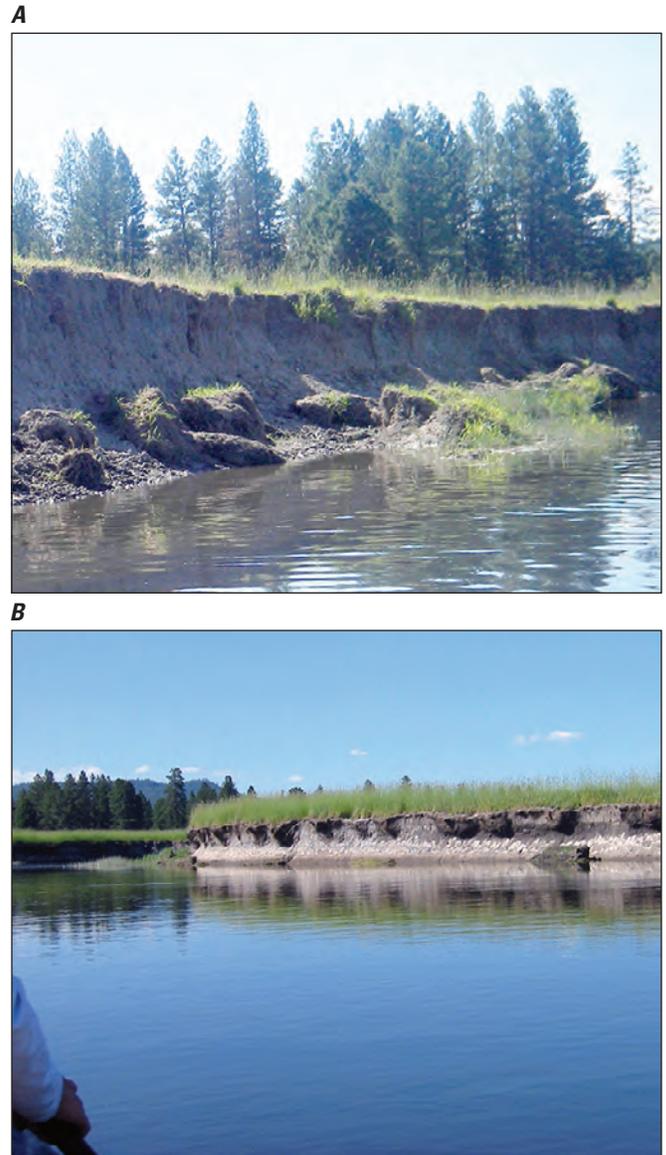
Figure 57. Examples of bank erosion with down-dropped blocks of flood-plain deposits, including (A) left-bank erosion in S'Ocholis Canyon valley segment (June 29, 2005), and (B) right-bank erosion in Kamkaun Spring valley segment (June 25, 2006), main-stem Sprague River, Oregon. Photographs taken by J.E. O'Connor, U.S. Geological Survey.

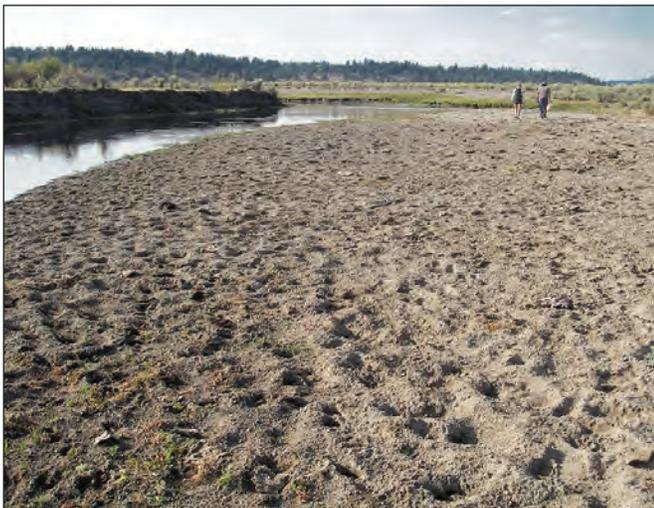
Figure 67. Trampled sand-and-gravel point bar looking upstream near Sycan River flood-plain kilometer 0.1 along Sycan River, Oregon. Photograph taken by J.E. O'Connor, U.S. Geological Survey, September 12, 2007.
