## *Upper Klamath Lake Watershed Assessment*

**June 2010**

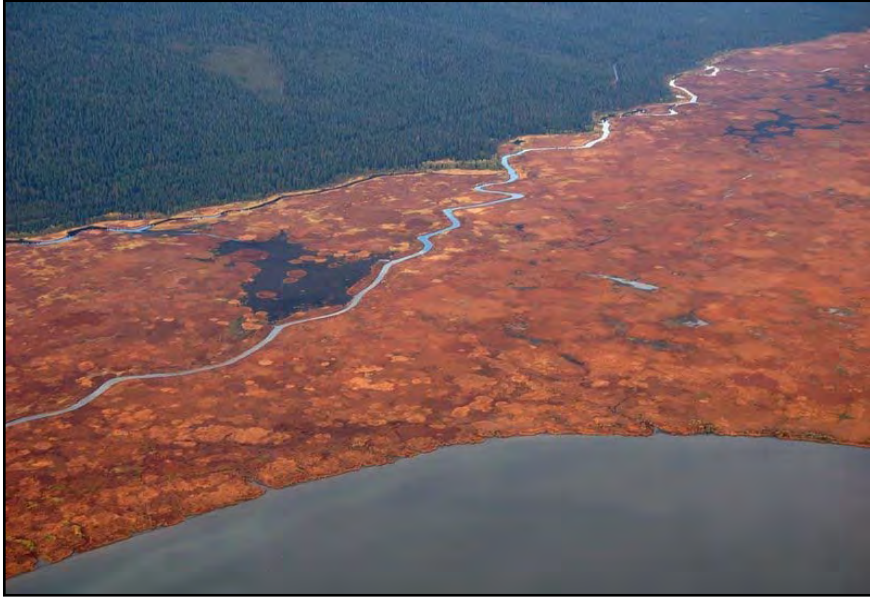
Figure 3-2. Aerial Photo of Crystal Creek, a Rosgen C/F channel (DEA 2009).

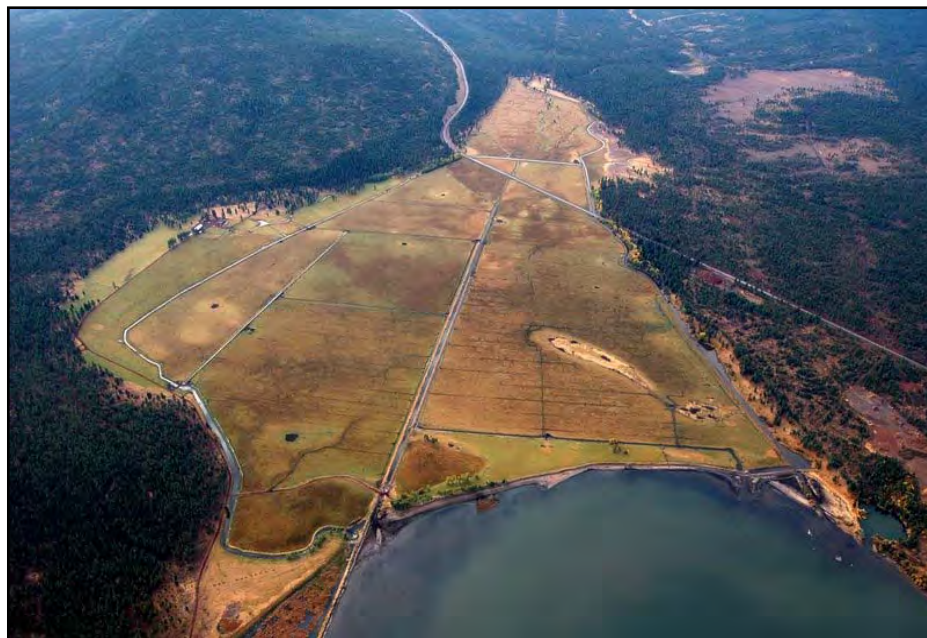
Figure 3-4. Aerial photo of Ditched portion of Denney Creek (DEA 2009).

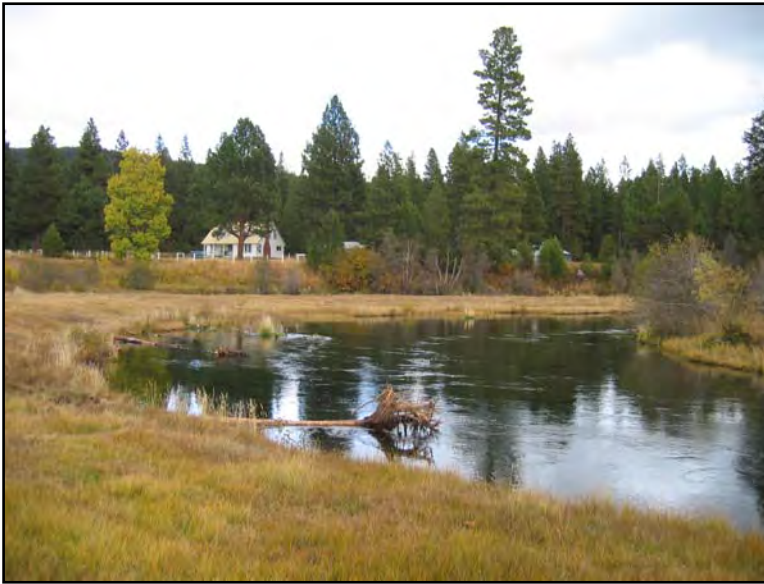
*Figure 3-7. Photo of habitat enhancement project along the Wood River (DEA 2009).*

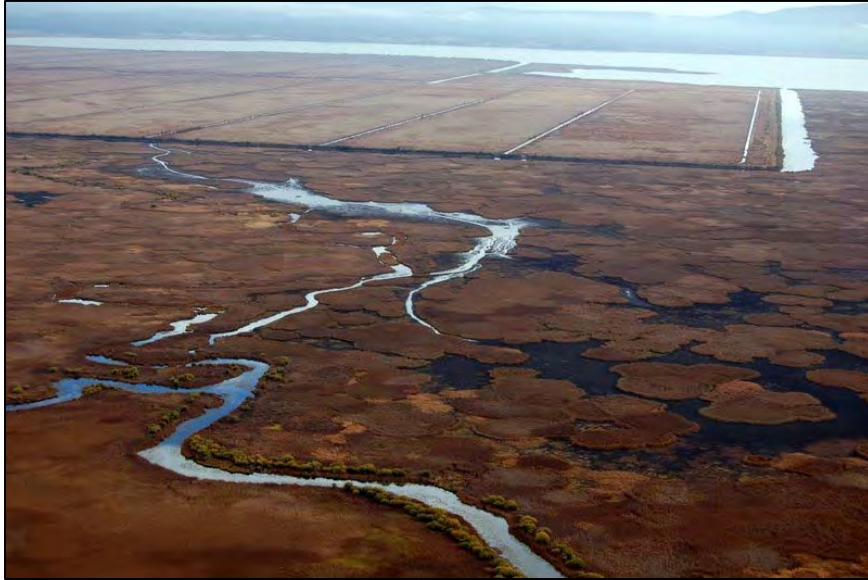
Figure 4-2. Aerial Photo of channels altered for drainage and irrigation (DEA 2009).

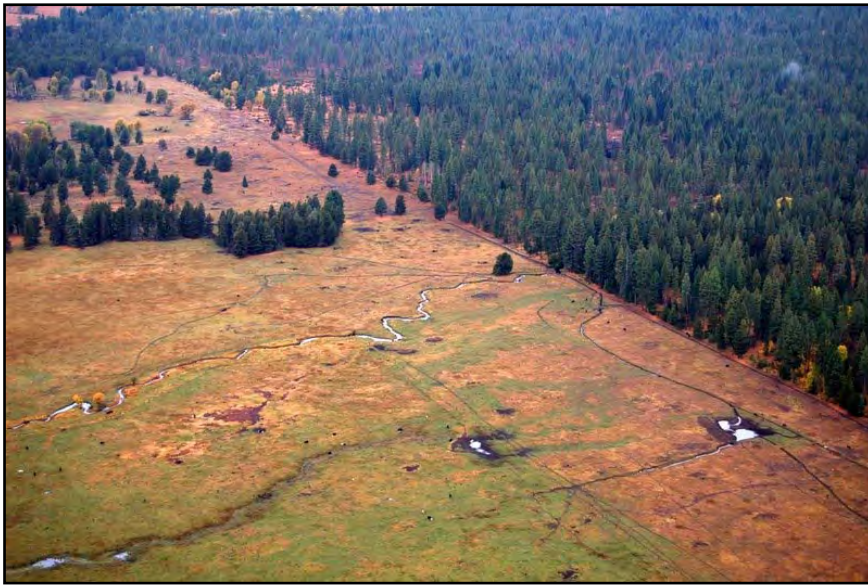
*Figure 6-1. Aerial photo of a channel lacking overhead canopy adjacent to forested land (DEA 2009).*

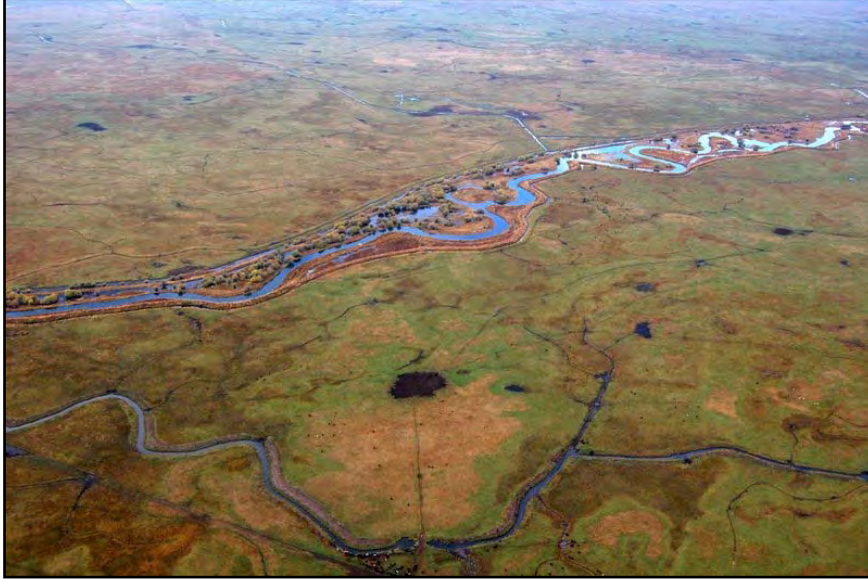
*Figure 6-3. Aerial photo of an example of scattered riparian cover along channels located on agricultural lands (DEA 2009).*

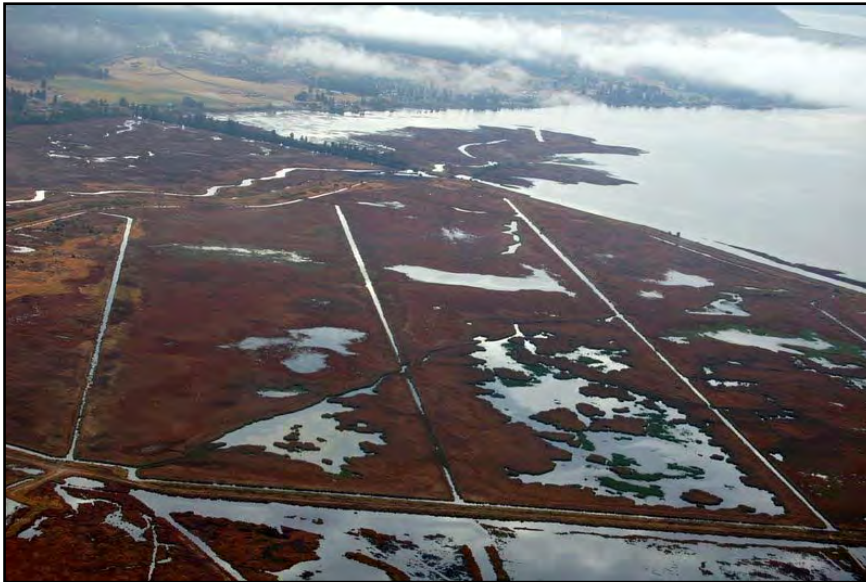
*Figure 6-4. Aerial photo of the Wood River Wetland in the foreground and the Wood River in the background (DEA 2009).*

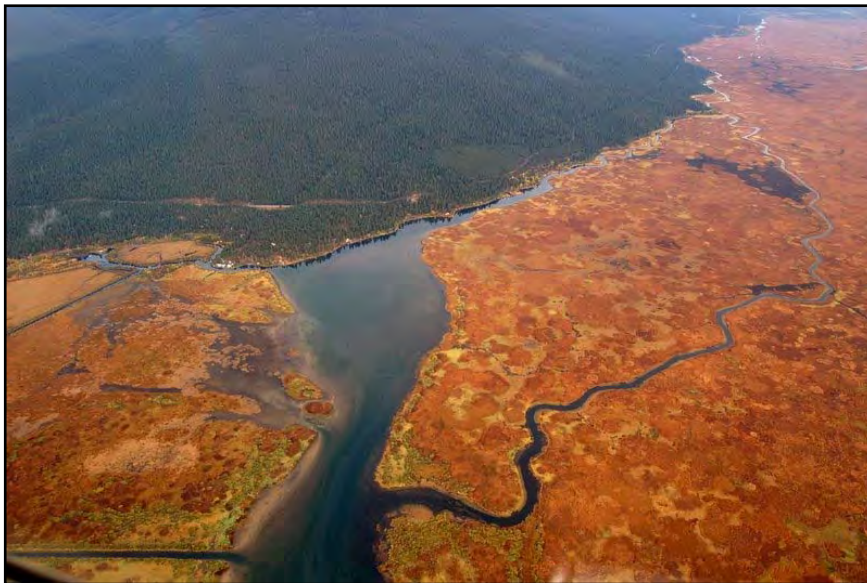
*Figure 6-6. Aerial photo of Pelican Bay including the mouths of Fourmile, Recreation and Crystal Creeks (DEA 2009).*

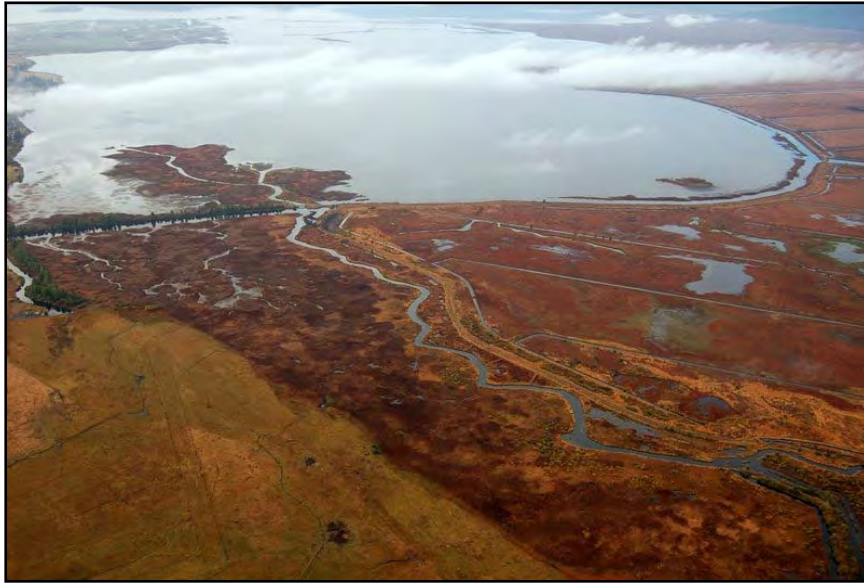
Figure 7-2. Aerial photo of the lower Wood River and Wood River Wetland, adjacent to Agency Lake (DEA 2009).

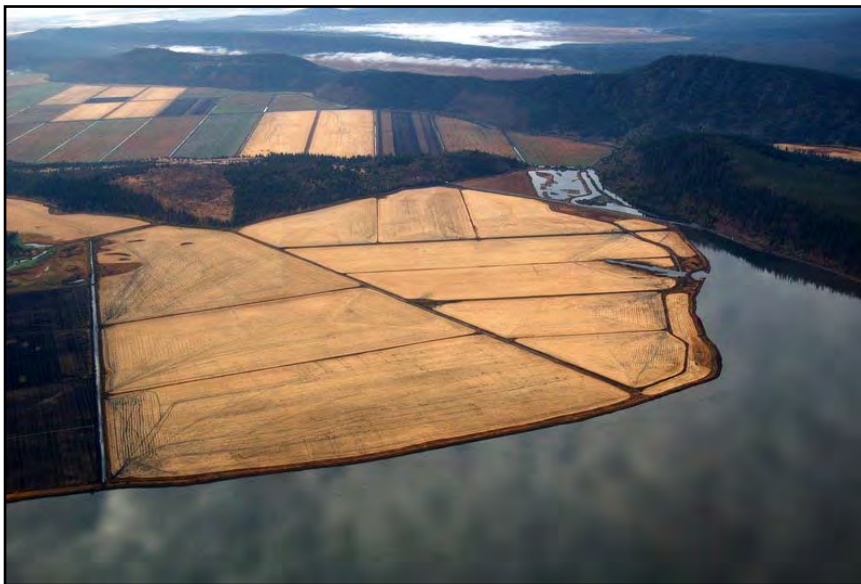
*Figure 7-3. Aerial photo of Caledonia Marsh, adjacent to Upper Klamath Lake (DEA 2009).*

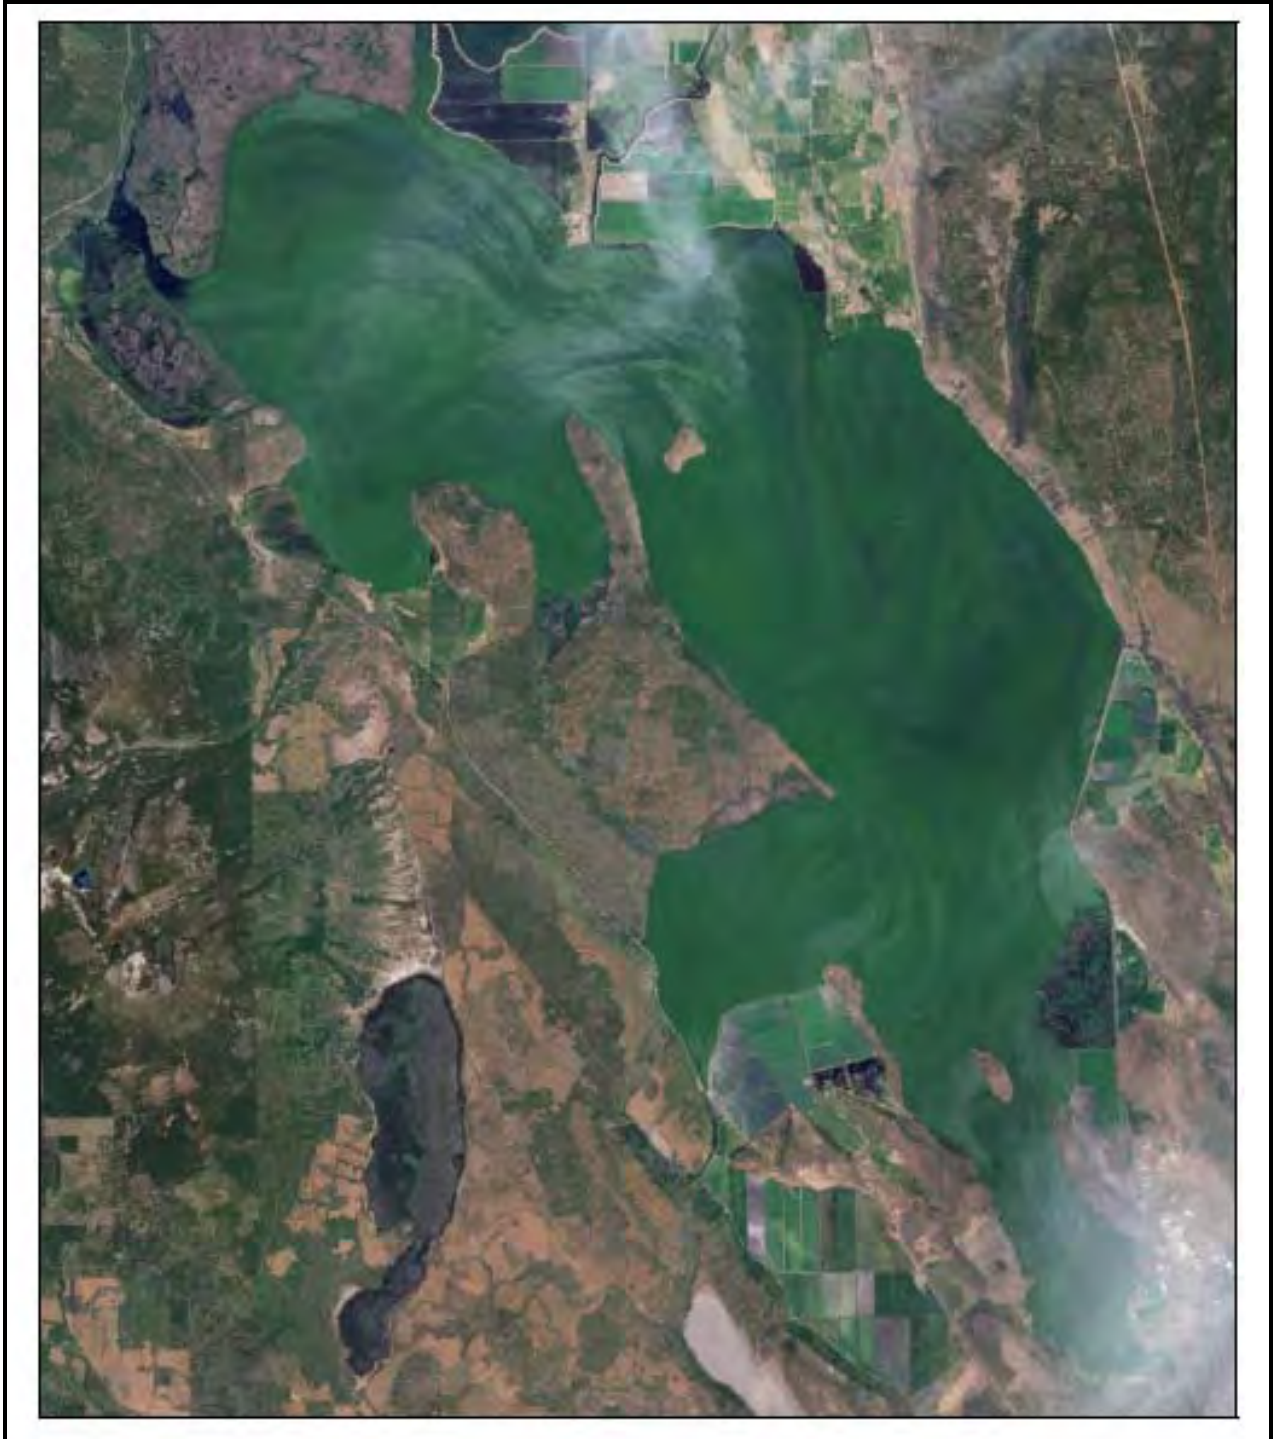
Figure 8-1. Photo of algal bloom (*Aphanizomenon flos-aquae*) in Upper Klamath Lake (DEQ 2002).

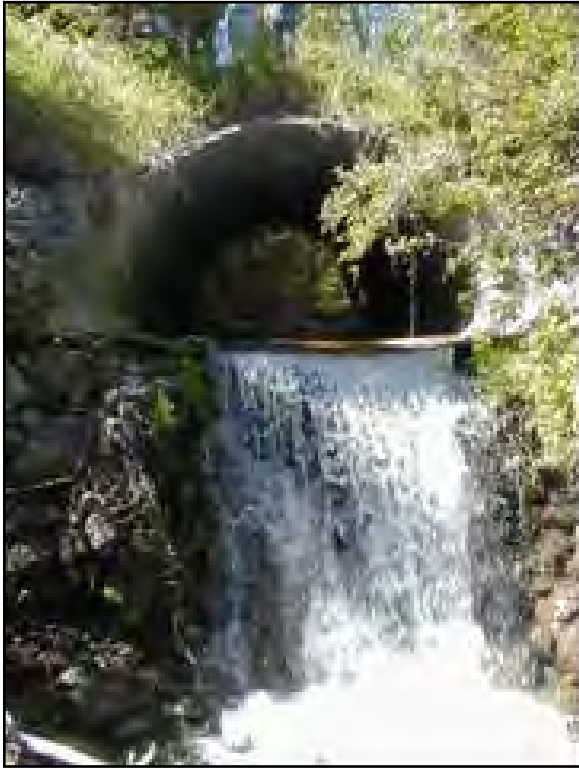
*Figure 9-7. Photo of Impassable Fish Barrier at Forest Road 3413-110 (USFS 2007)*

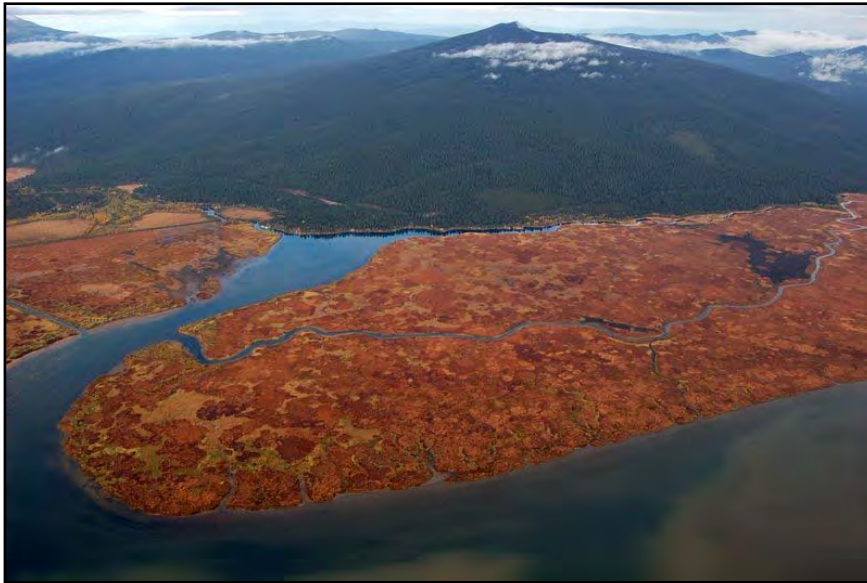
*Figure 9-8. Aerial photo of Recreation and Crystal creeks with Pelican Butte in background. Recreation Creek flows along base of the hillside, while Crystal Creek flows completely through emergent marsh area (DEA 2009).*
